BOSTON REDEVELOPMENT AUTHORITY  
INTERIM REPORT  
ON  
UTILITY SYSTEMS  
FOR  
BACK BAY GNRP AREA  
MASS. R-47

**CHARLES A. MAGUIRE & ASSOCIATES**

ENGINEERING REPORT  
ON  
UTILITY SYSTEMS  
FOR  
BOSTON REDEVELOPMENT AUTHORITY  
IN  
BACK BAY GNRP AREA

PROJECT NO. MASS. R-47

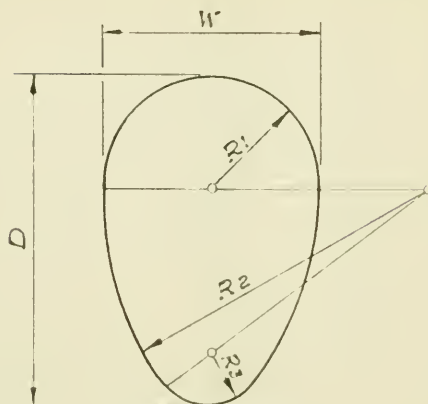
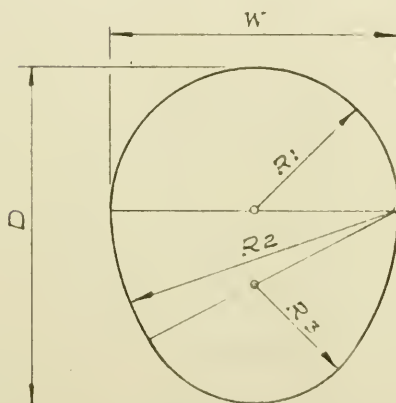
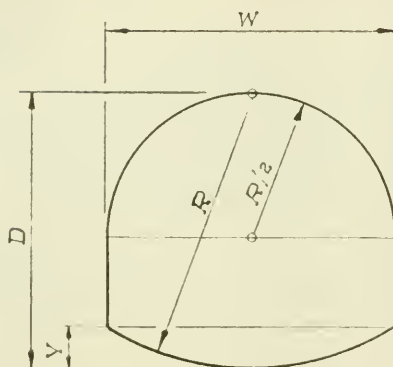
TYPICAL SECTIONS  
EXISTING SEWERS  
—BACK BAY—

The hydraulic radius has been determined on the basis of size and shape as noted on the following drawings. Where exact shapes were not readily available, an assumption has been made on the basis of an evaluation of known construction in the same area and of approximately the same age. Exhibits 47-4 and 47-5 give the dimensions and proportions for typical sewer shapes of the majority of the sewers encountered in the Back Bay GMRP Area. The basic shapes are circular, egg, ovoid, horseshoe and U-shape. It has been determined that variations from these shapes could be equated to a basic

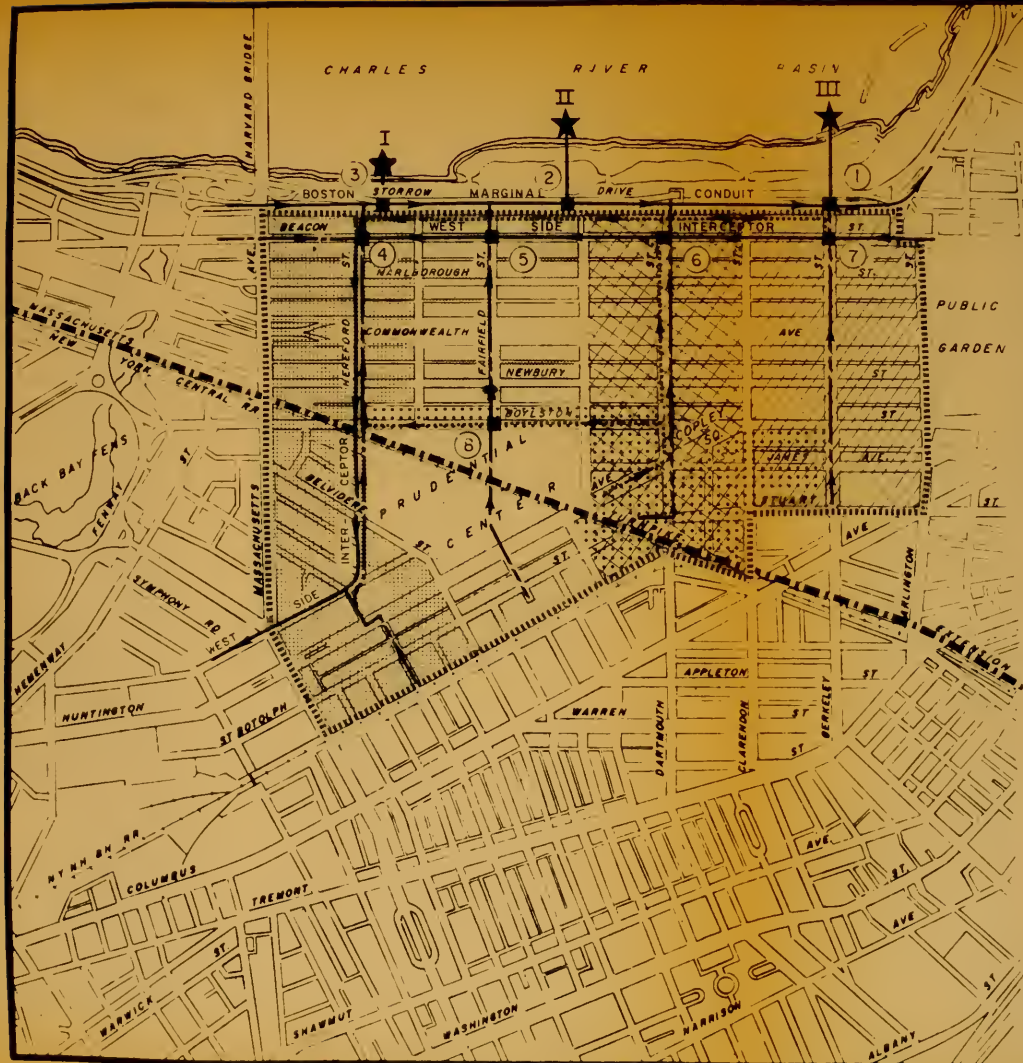
EXHIBIT 47-6

The main combined sewers in the Back Bay GMRP Area discharge low flows to the West Side Interceptor. Overflows from these sewers, numbered 4 through 7 on Exhibit 47-6 and tabulated hereafter, discharge to the Boston Marginal Conduit through overflow conduits in Berkeley, Dartmouth, Fairfield and Hereford Streets. The present surcharged condition of the Boston Main Drainage System limits the available capacity of the West Side Interceptor. This results in a high frequency of overflow from the local systems.
